# **FABRICATION AND VERIFICATION TESTING OF ETM 30 CM DIAMETER ION THRUSTERS**

**FINAL REPORT**

**ION PHYSICS DEPARTMENT STAFF  
HUGHES RESEARCH LABORATORIES  
A DIVISION OF HUGHES AIRCRAFT COMPANY  
3011 MALIBU CANYON ROAD  
MALIBU, CALIFORNIA 90265**

**CONTRACT NAS 3-17803  
JAMES S. SOVEY, PROGRAM MANAGER**

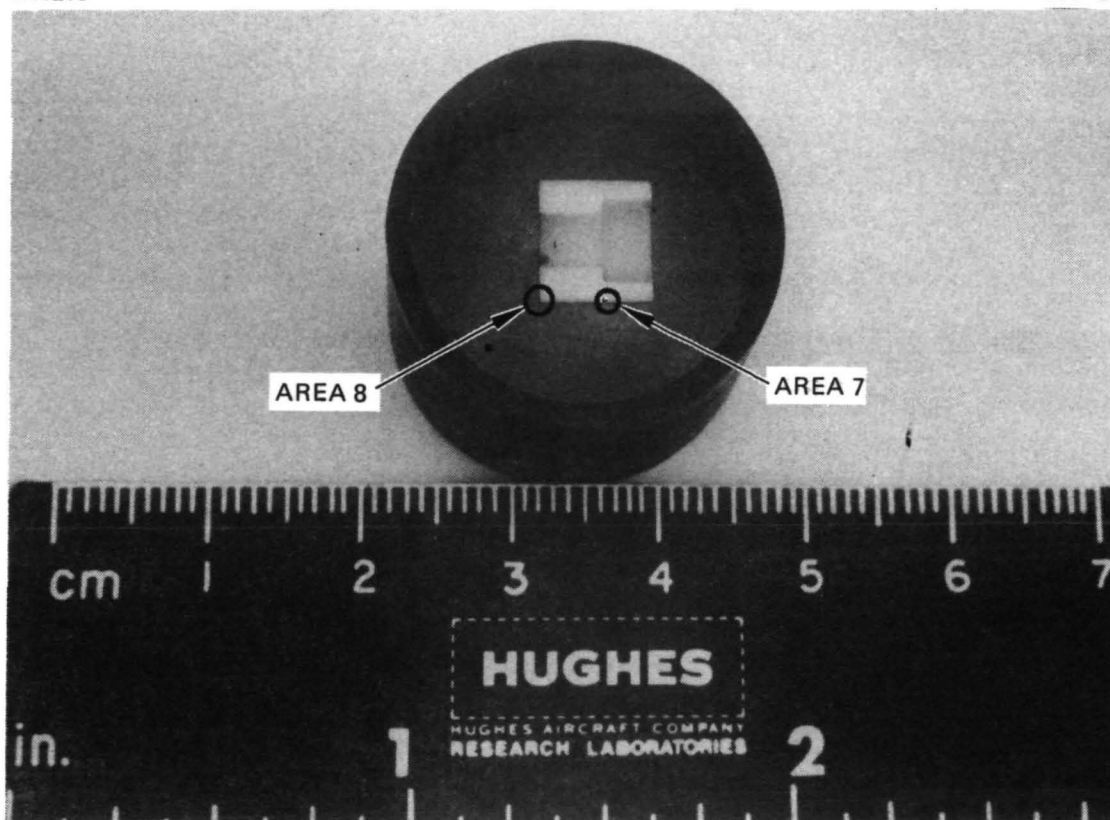
Figure A-32. Cross section of anode support insulator.

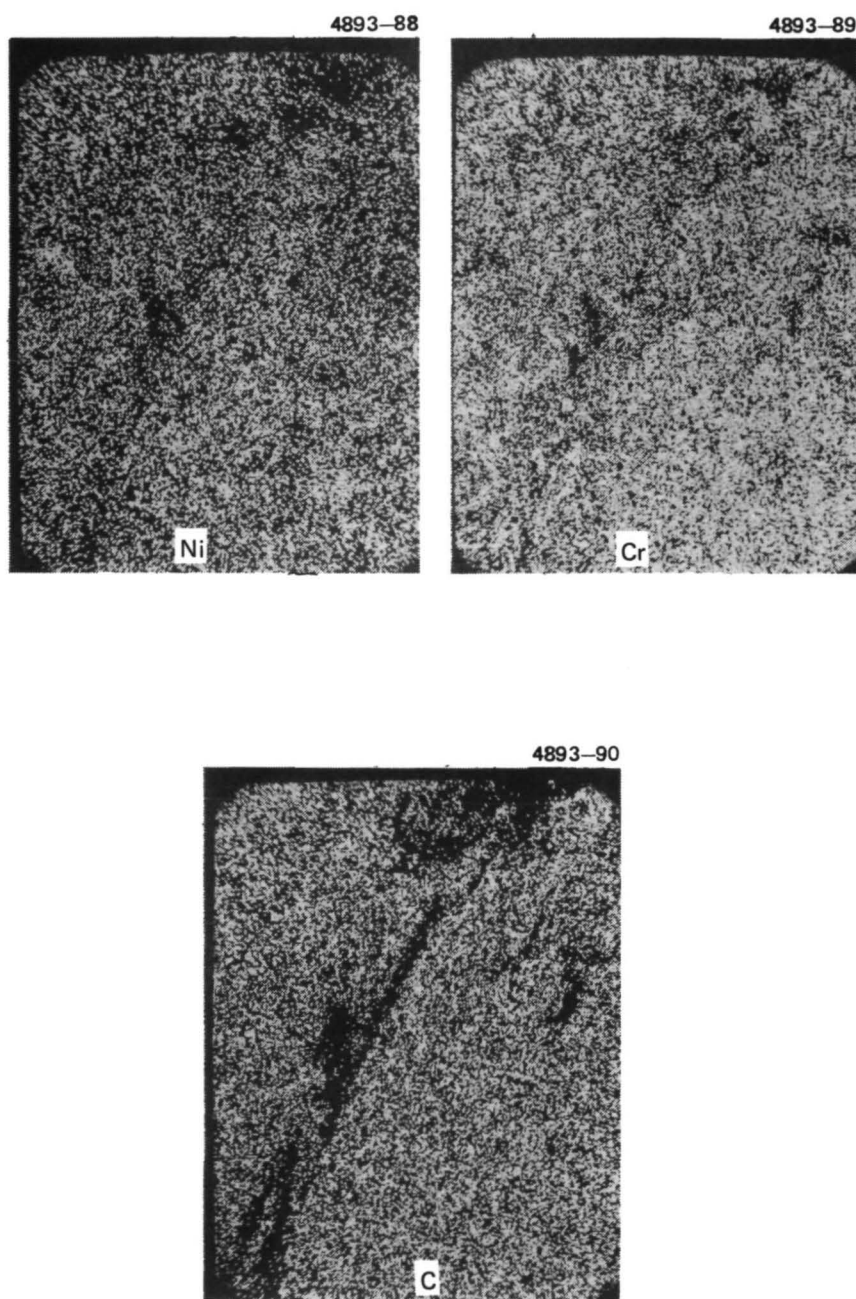
On the basis of the examination discussed above, it was impossible to discern what caused the damage to anode supports No. 2 and No. 6. Consequently, one of the failed insulators, No. 6, and the surviving insulator, No. 4, were encapsulated and cross sectioned as shown in Figs. A-31 and A-32 with the areas of interest identified. Magnification of Area 1 is shown in Fig. A-33(a). The screw head and washer are composed of stainless steel and the melted region contains Fe, Ni, Cr, Ti, Mn, Si, Co, and C in decreasing order of proportion as determined by SEM microprobe. It is apparent that the portion of the anode which was held between the stainless-steel washer and the ceramic has been completely absorbed in the alloy melt seen. An SEM reproduction and  $K_{\alpha}$  X-ray analysis of the spatial distribution of some of these elements is included in Fig. A-34.

Figure A-34. Continued.

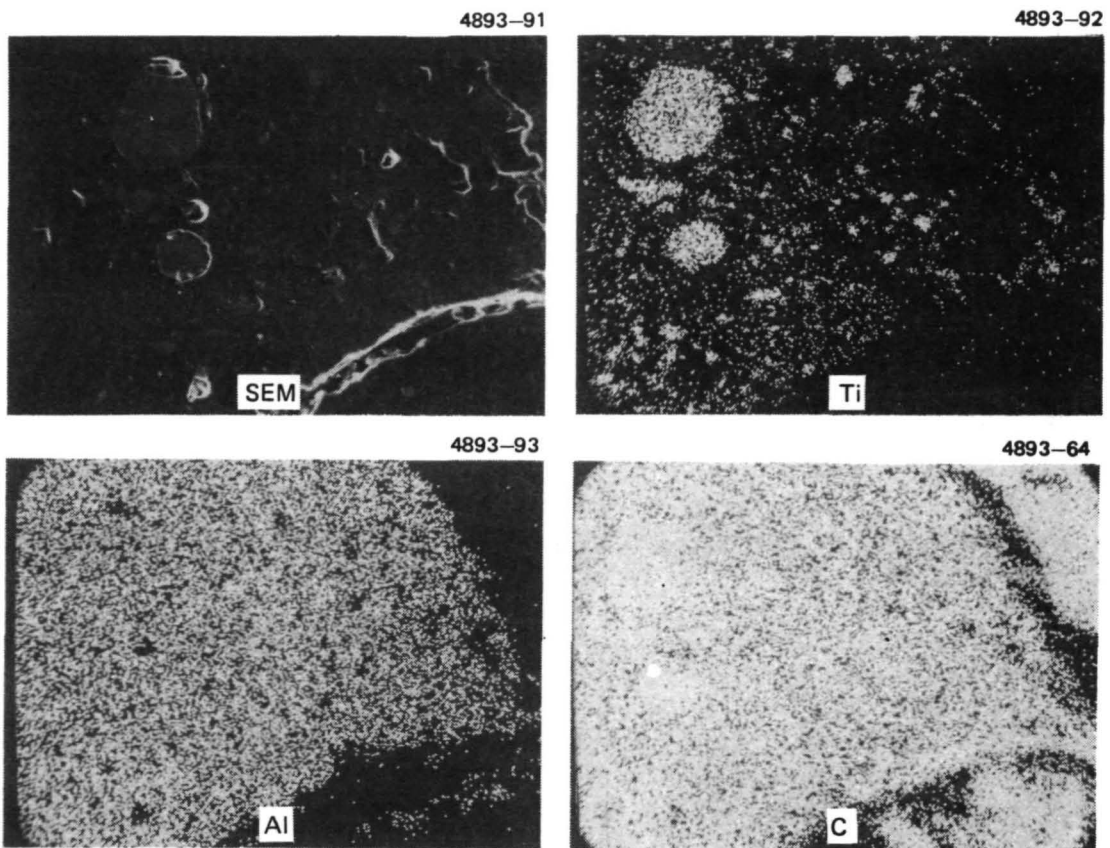
AREA 2  
200X

Microscopic examination of Area 2 shows that the titanium discharge chamber shell is eroded on the interior surface adjacent to the point of contact with the ceramic anode support insulator and that this ceramic has been melted in the vicinity of this point of contact (see Fig. A-33(b), 50X and 500X). Melting of the ceramic is indicated by the dendritic structure of the cross-sectioned ceramic. Titanium appears to be distributed throughout this melted region of the insulator, which would imply some sort of "wicking" or melting. This latter observation was substantiated by the SEM X-ray scan shown in Figs. A-35(a) and (b). The elements contained in this area are, in decreasing order of concentration, Al, C, O, Ti, Si, and Ca (the high percentage of C may be a consequence of the carbon coating necessary to prevent the sample from charging up in the SEM). Thus it appears that the interaction seen between the anode and the anode support elements is a consequence of melting. Considering the elements involved, the lowest melting point eutectic that could occur would be for Al and Ni at 640°C. All other binary combinations yield higher melting points. This temperature is well above ambient for any part of the discharge chamber (excluding the cathode tip). Although the presence of mercury might have some influence on the metallurgical behavior, it is considered more probable that intense heating occurs during some form of transient occurrence such as a vacuum arc across the insulator surface.

Figure A-35. Scanning electron microscope photo and  $K_{\alpha}$  X-ray analysis of area 2 of damaged anode support.

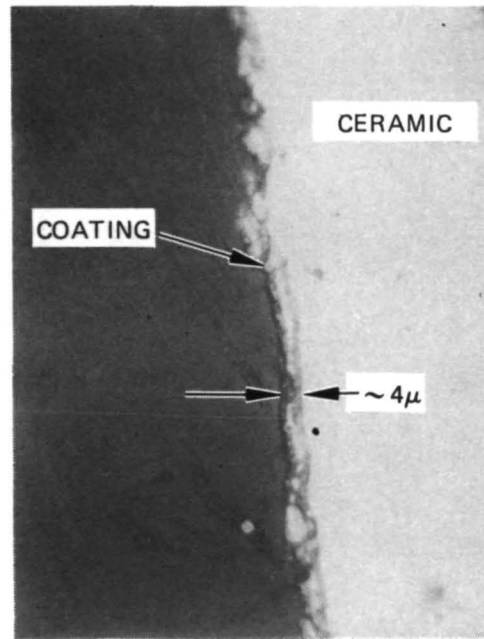
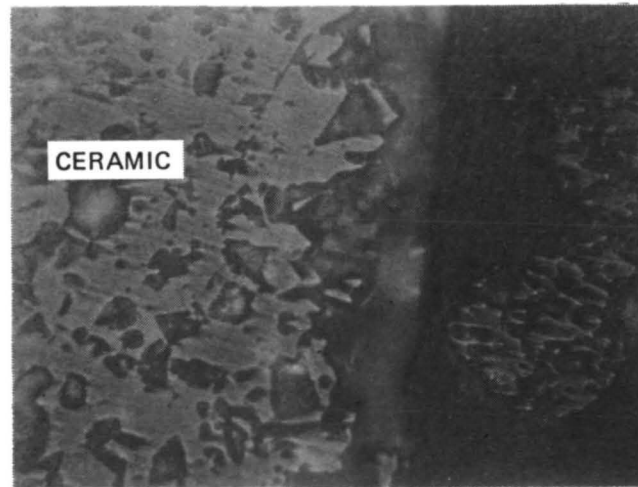
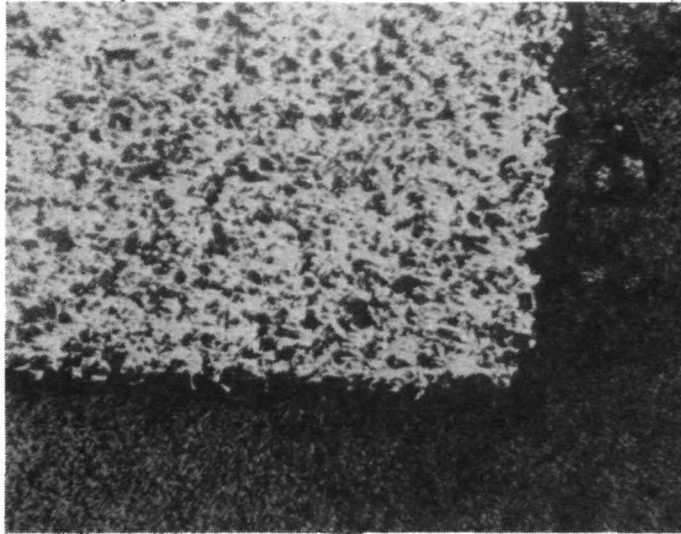
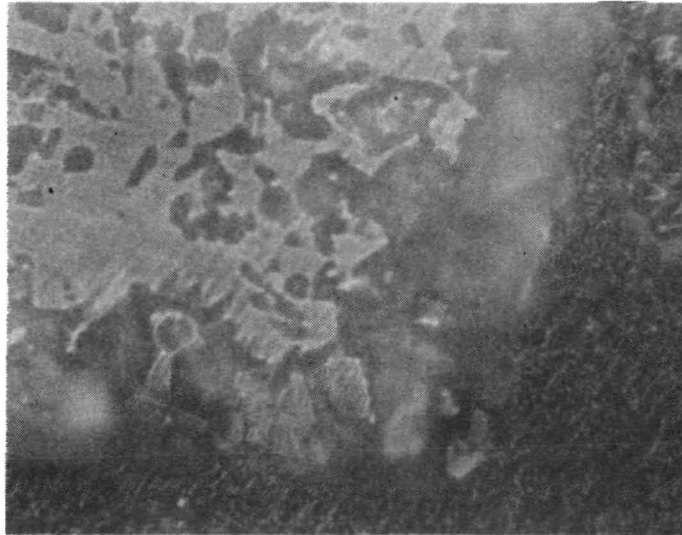
On the supposition that some form of insulator deterioration might have contributed to initiation of the phenomena that resulted in melting of the anode support insulator, the ceramic material was examined further in the areas shown as 3 through 8 in Figs. A-31 and A-32. The magnified photograph of Area 3, shown in Fig. A-36(a), seems to show a coating of about 4  $\mu\text{m}$  thickness. An attempt to scan the coating in this area with the SEM microprobe showed only the elements C, Al, O, Ca, Si, and Cl. A second attempt in Area 6 produced Ti and Fe as well (SEM and the Al  $K_{\alpha}$  X-ray scan are shown as Fig. A-37). Area 4 is in the damaged area, and it was thought that if the ceramic, which is predominantly  $\text{Al}_2\text{O}_3$ , was reduced to produce elemental Al, it would be possible to detect this by comparing the

Figure A-36. Magnified view of regions 3, 7, and 8 of anode support No. 6.

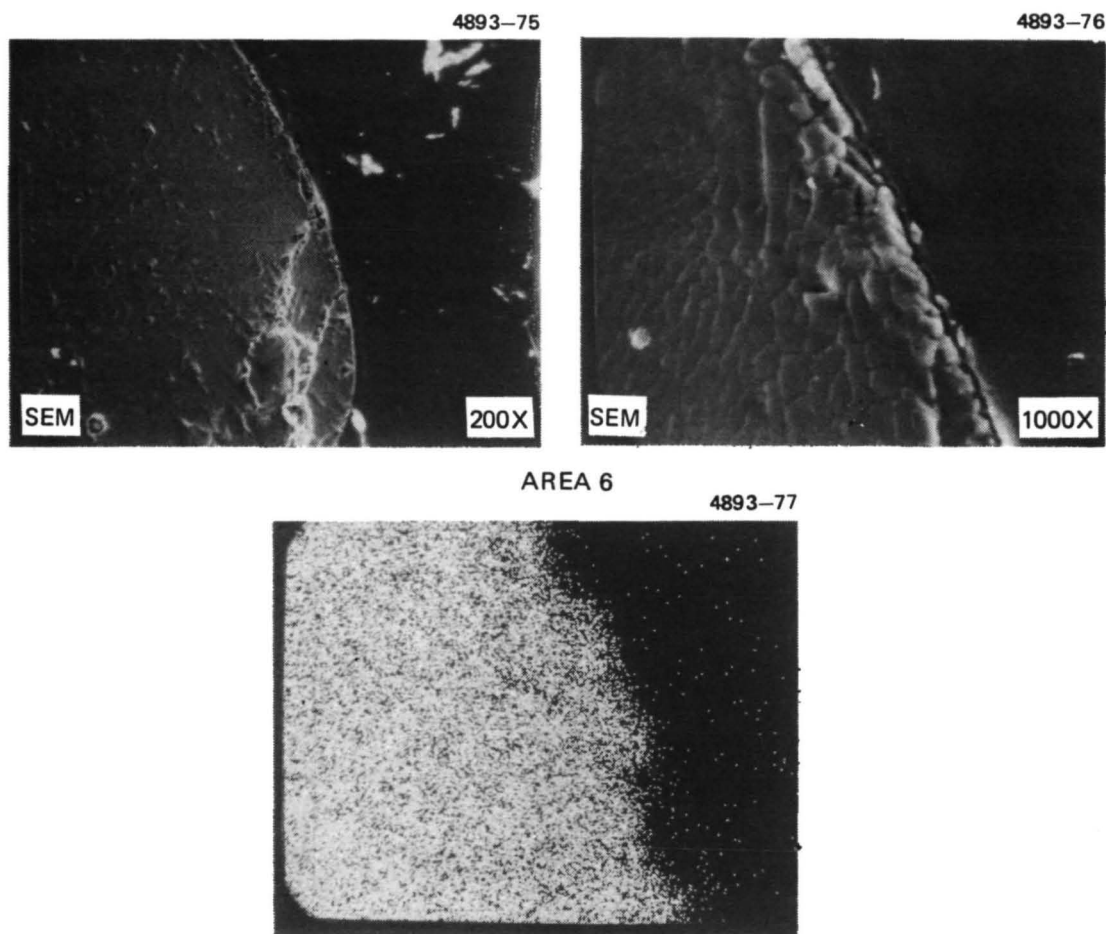
Figure A-37. SEM photo and  $K_{\alpha}$  X-ray analysis of area 6 of anode support No. 6.

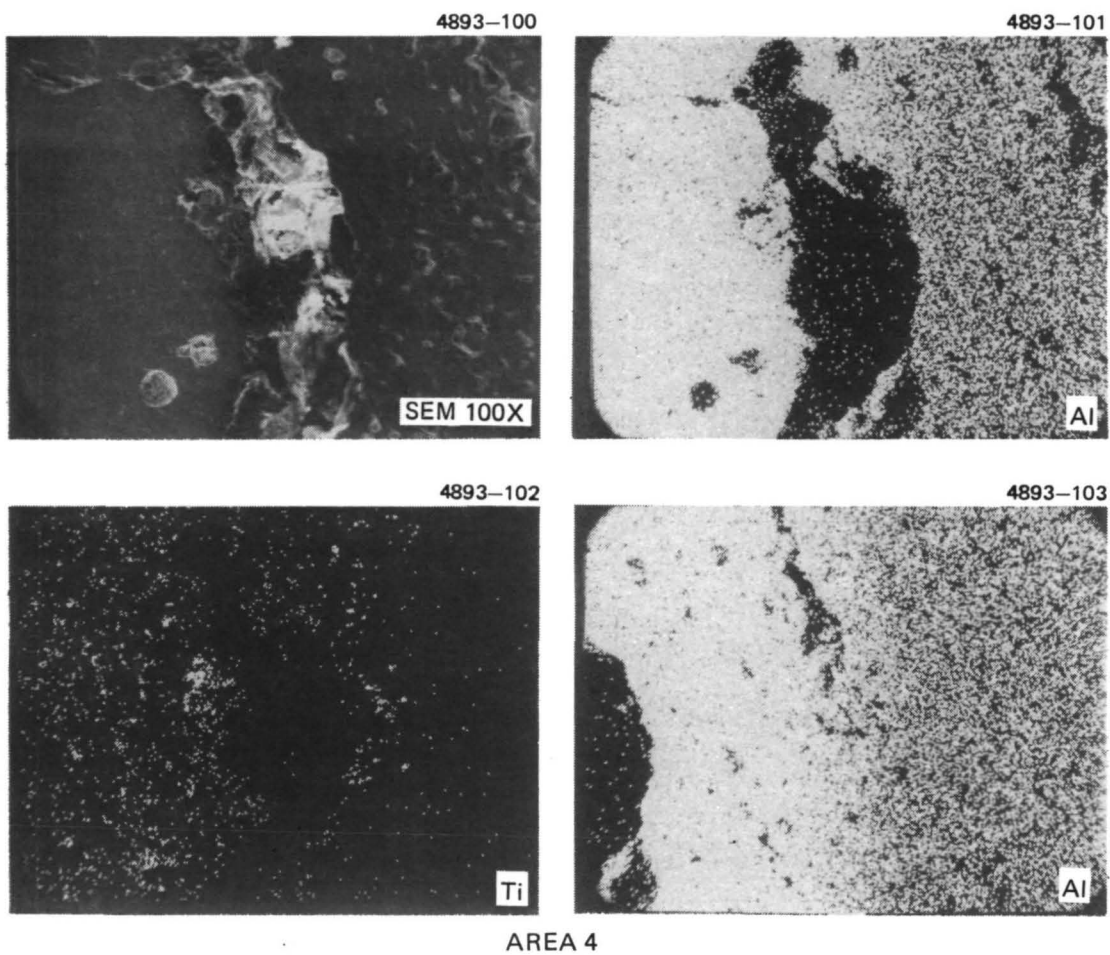
relative concentrations of Al and O in the damaged and undamaged areas. Figure A-38 shows an attempt to compare the Al signals from the SEM microprobe. Although it appears that the damaged area (left side of the void) has a greater concentration of Al in Fig. A-38, this is not necessarily the case, as shown by Fig. A-38 where the scan field has been shifted slightly. Thus, the apparent gradation in the concentration of Al depends more on the scan location than on the location in the material. Area 5, which is located in what is thought to be undamaged material, shows no real variation in concentration of Al, no titanium; the remaining impurities, Si and Ca, seen in Fig. A-39 are probably remnants of the polishing compound trapped in the normal voids of the  $\text{Al}_2\text{O}_3$ . Areas 7 and 8 appear identical to area 5 under the microscope, and no coating was discernible on the insulator surface. Consequently, these areas were not examined further with the SEM microprobe.

Figure A-38. SEM photo and  $K_{\alpha}$  X-ray analysis of area 4 of anode support No. 6.

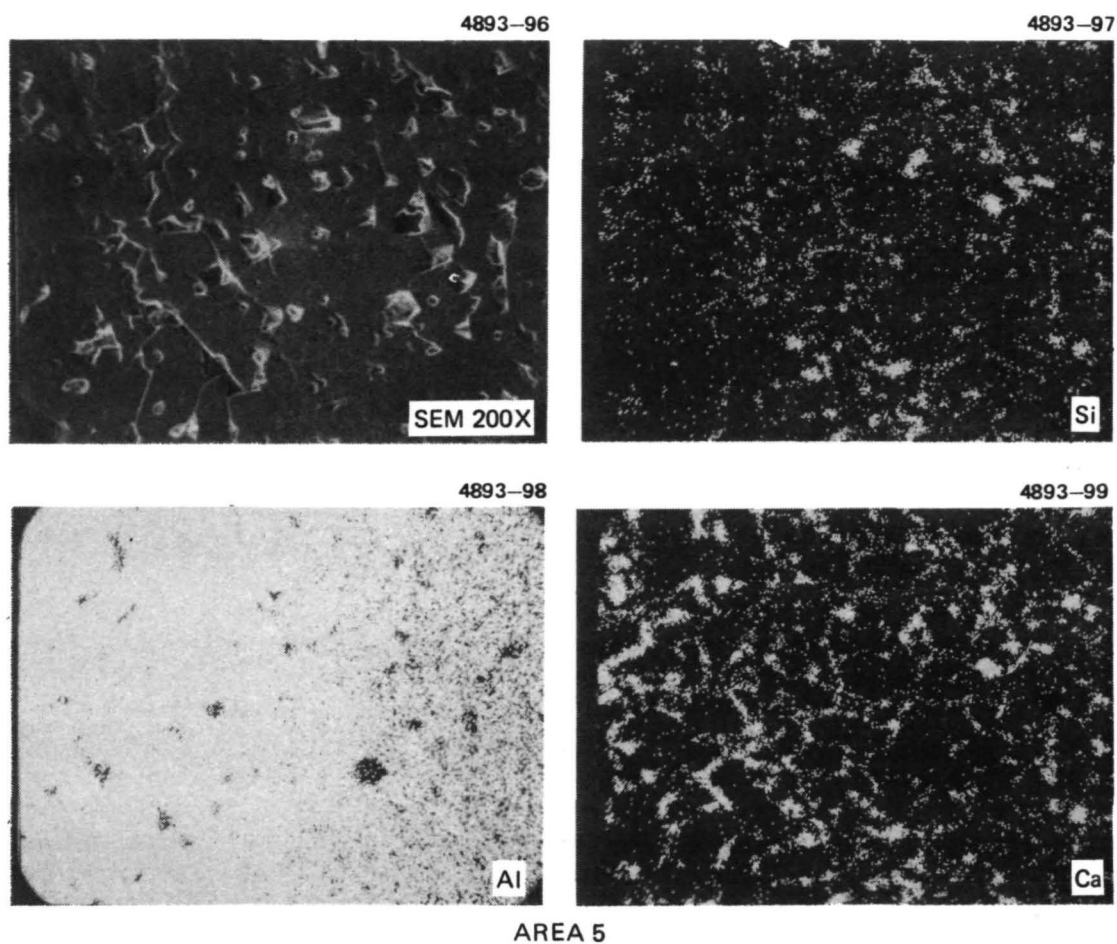
Figure A-39. SEM photo and  $K_{\alpha}$  X-ray analysis of area 5 of anode support No. 6.

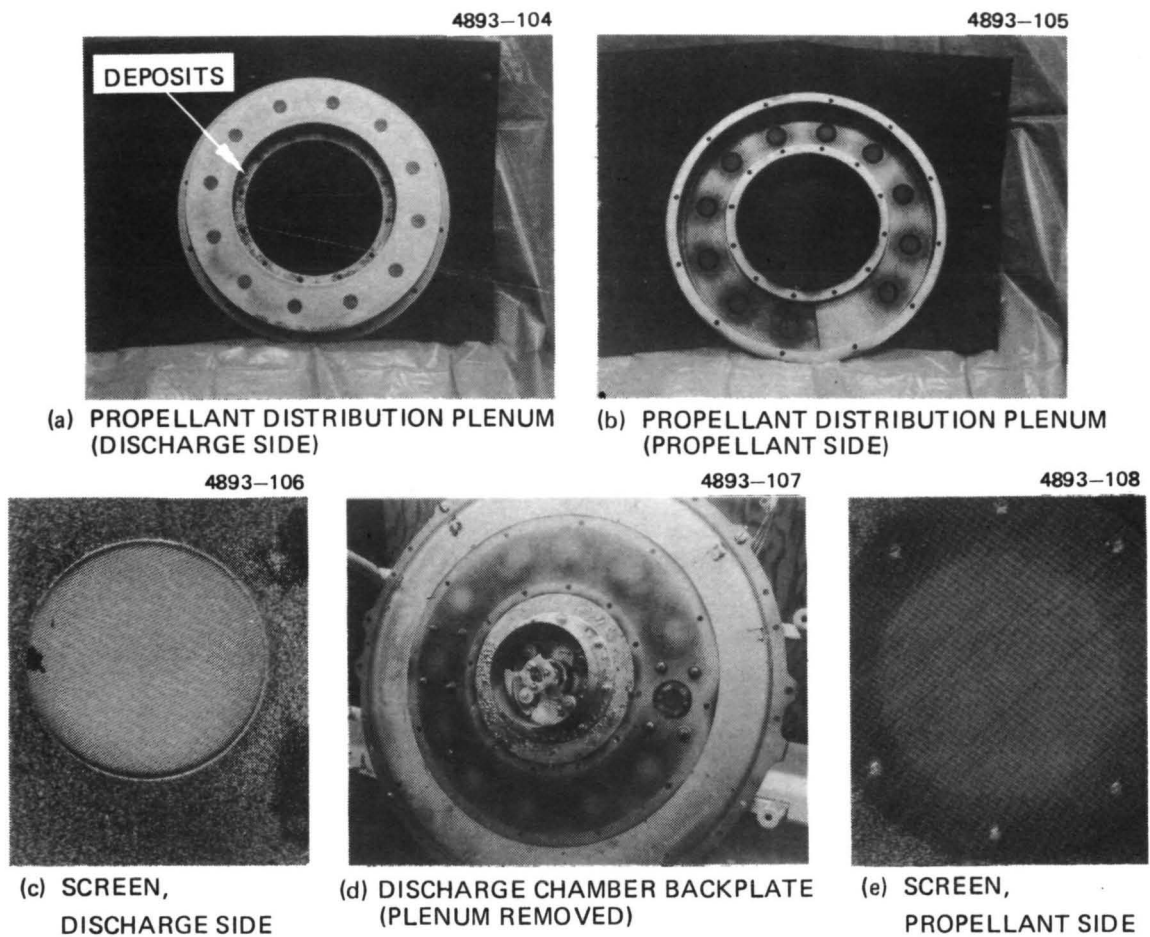
Figure A-41. Discharge and propellant sides of plenum and screen which covered plenum ports.

Although some concern has been expressed by Hughes and NASA metallurgists with respect to embrittlement of titanium by mercury, there was no evidence of embrittlement in the plenum or other discharge chamber components after 10,000 hours of exposure to mercury vapor. This is to say that no titanium part cracked in the manipulation which was necessary to disassemble the thruster components, and the sheet metal parts (such as the plenum and anode) seemed as flexible as new parts. No tests were made to determine hardness or yield strength since these quantities are not considered of primary importance to thruster operation after a thrust system achieves orbit.

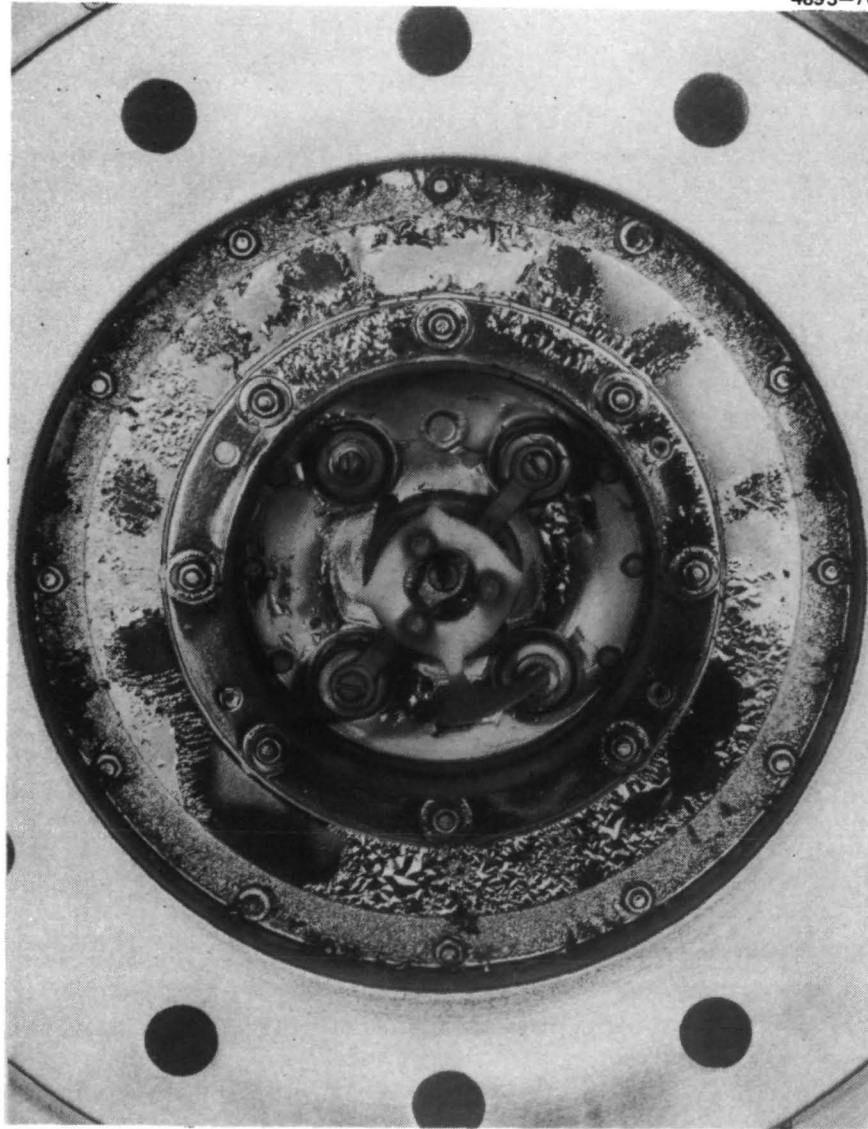
This assembly and some of its components are the most severely worn of the thruster parts and exhibit radical modification of component dimensions, as indicated earlier in comparing Figs. A-14 and A-15. The extensive wear seen on these components is considered to be a consequence of ion sputtering, presumably dominated by doubly charged ions. Close-up photographs of this assembly illustrating the damage are presented in Figs. A-42 to A-45. By referring back to Fig. A-15, most of the component damage is obvious in these photographs. Some of the less obvious wear or damage is pointed out specifically in Figs. A-44 and A-45. One point of interest to be noted here is that the baffle coil sheath and the cathode radiator are eroded while the keeper electrode and most of the other cathode potential surfaces in their vicinity are

Figure A-42. Cathode pole piece/magnetic baffle assembly.

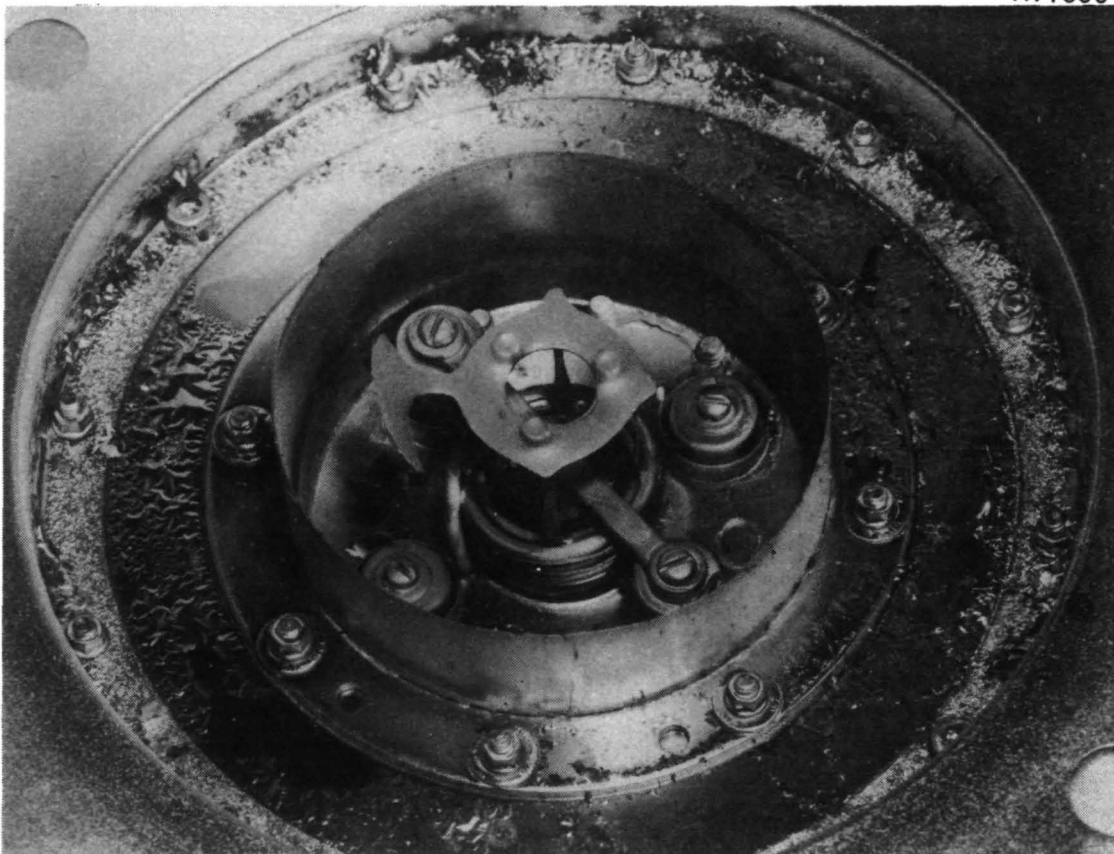
Figure A-43. Cathode pole piece/magnetic baffle assembly.

It is apparent in Figs. A-43 and A-44 that removal of the machine screws which secure the baffle to its support is a questionable operation because of the erosion of the baffle supports, which weakens the structure, and because the heads of the screws are eroded to the extent that they cannot be gripped by any tool. After several unsuccessful attempts at removing these screws, the entire support was removed with a high speed abrasive wheel. Several photographs showing the structure as it was removed in several views and variations in focus are included in Fig. A-51. Note that the erosion on the baffle fastening screws is predominantly on the inner side. It is also of interest to note that a thin lip of the baffle remains extending beyond the outer diameter of the baffle support, as if the baffle had been shielded from internally generated ions by the baffle support (further evidence to support the concept of erosion by ions from the cathode plasma). The wear on this structure is documented and recorded in Fig. A-52 by dimensional measurements at the locations indicated. The most wear occurred on Member C, in agreement with the asymmetry in wear seen on the baffle itself and the pole piece.

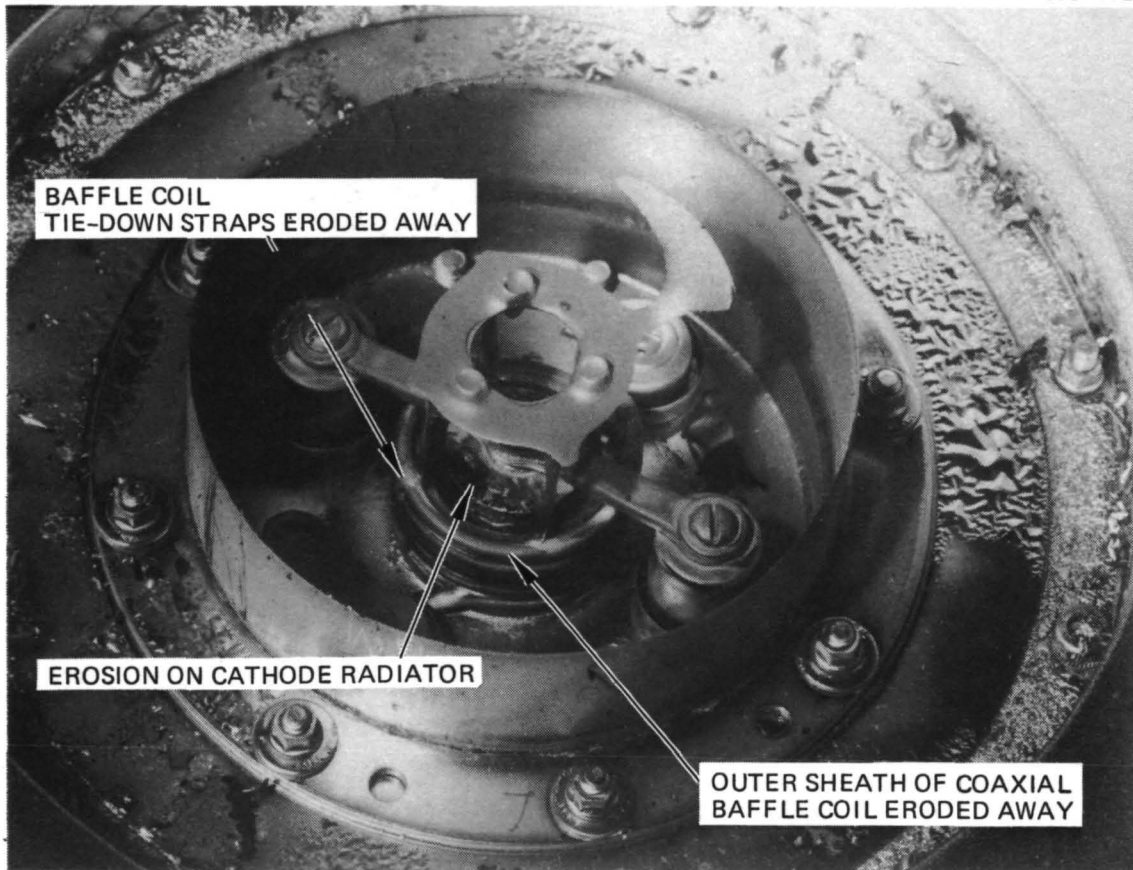
Figure A-44. Cathode pole piece/magnetic baffle assembly.

heavily deposited. The erosion patterns have an imperfect symmetry that seems related to the orientation of the baffle coil terminations. The outer conductor of the coaxial baffle coil is seen to be eroded away in Fig. A-44, exposing the insulator over a relatively large area, while the counterpart of the coil seen in Fig. A-43 shows penetration of the coils outer sheath over a relatively smaller area. Similarly, a remnant of the baffle coil tie-down strap can be seen on the downstream side of the coil in Fig. A-43, whereas the counterpart strap is seen in Fig. A-44 to be completely eroded away on the downstream end and barely visible on the upstream end. It has not been possible to formulate a cohesive explanation for the erosion seen on the baffle coil and cathode radiator. The generally accepted model of the discharge chamber plasma potential distribution would place the plasma potential within the cathode pole piece at approximately the keeper voltage. Thus, no doubly charged ions should be formed in the region and singly charged ions should not be capable of causing damage. It is possible that this erosion is entirely a consequence of exposure to high-energy ions from the discharge chamber after the baffle was eroded away. However, taking note of the pattern of baffle wear in these photographs, it is apparent that remnants of the baffle show a "spoke-like" configuration and these remaining elements are aligned with the four baffle support members. This could be interpreted as a shielding of the baffle from ions originating within the support structure or as a magnetic field effect. No conclusive evidence exists to determine whether the erosion pointed out in Fig. A-44 is "typical" or a consequence of operation without the baffle.

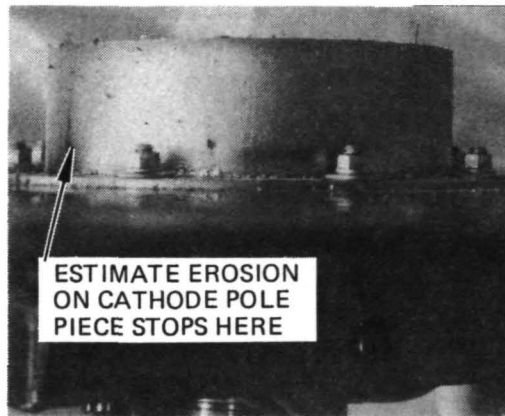
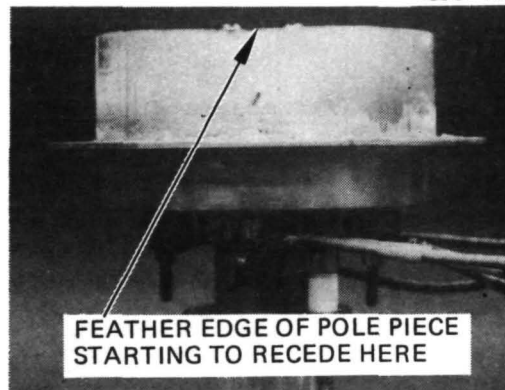
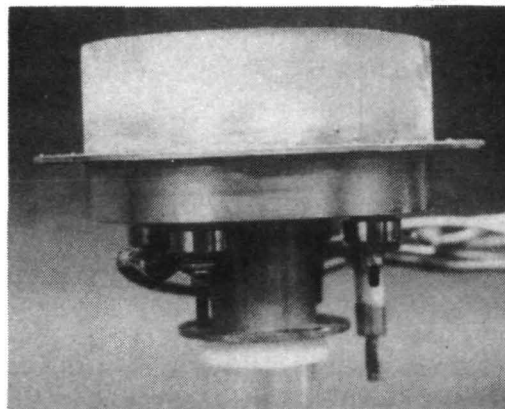
Figure A-45.  
Cathode pole piece/magnetic  
baffle assembly.

Similarly, in examining the erosion of the baffle and cathode pole piece, it has not been possible to determine where the eroding particles originate. The cylindrical pole piece is worn to a "feather" edge on the downstream side, and, as shown in Fig. A-45(b), this wear has begun to reduce the pole piece length. The erosion seems to end upstream of the region indicated in Fig. A-45(a).

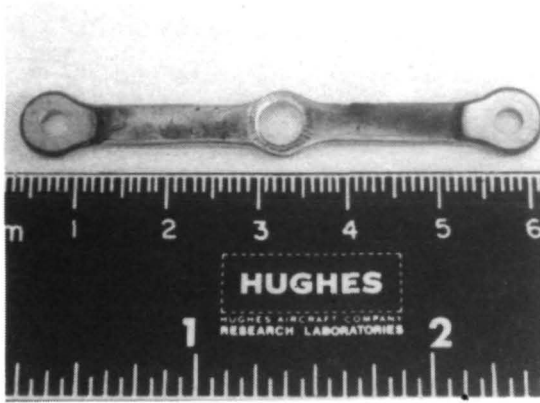
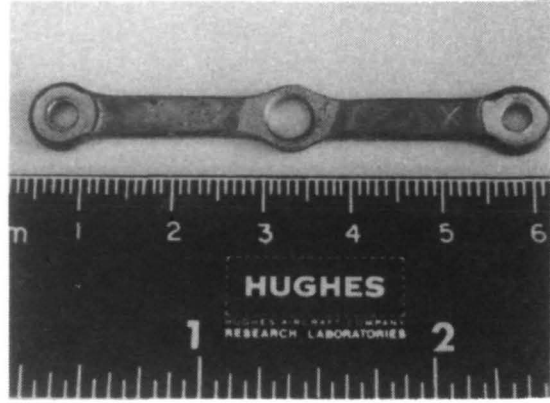
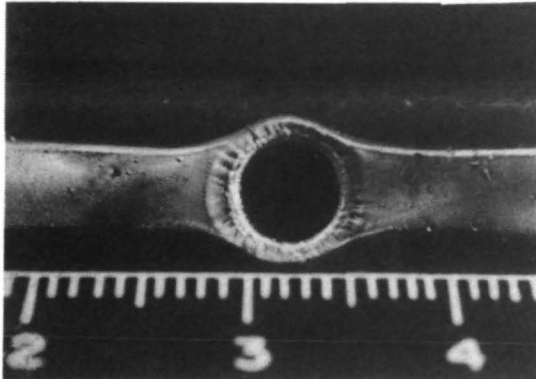
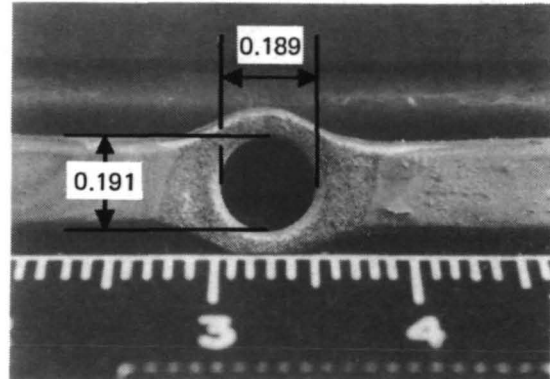
Figure A-46. Cathode keeper.

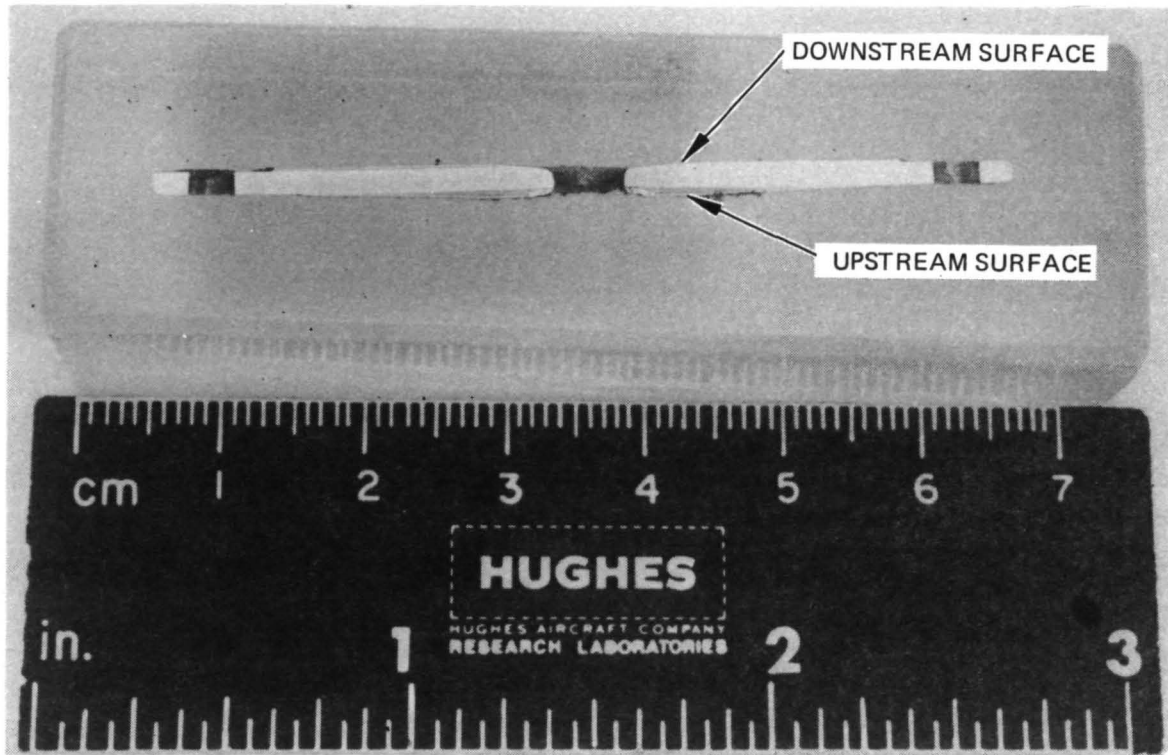
Figure A-47. Cathode keeper.

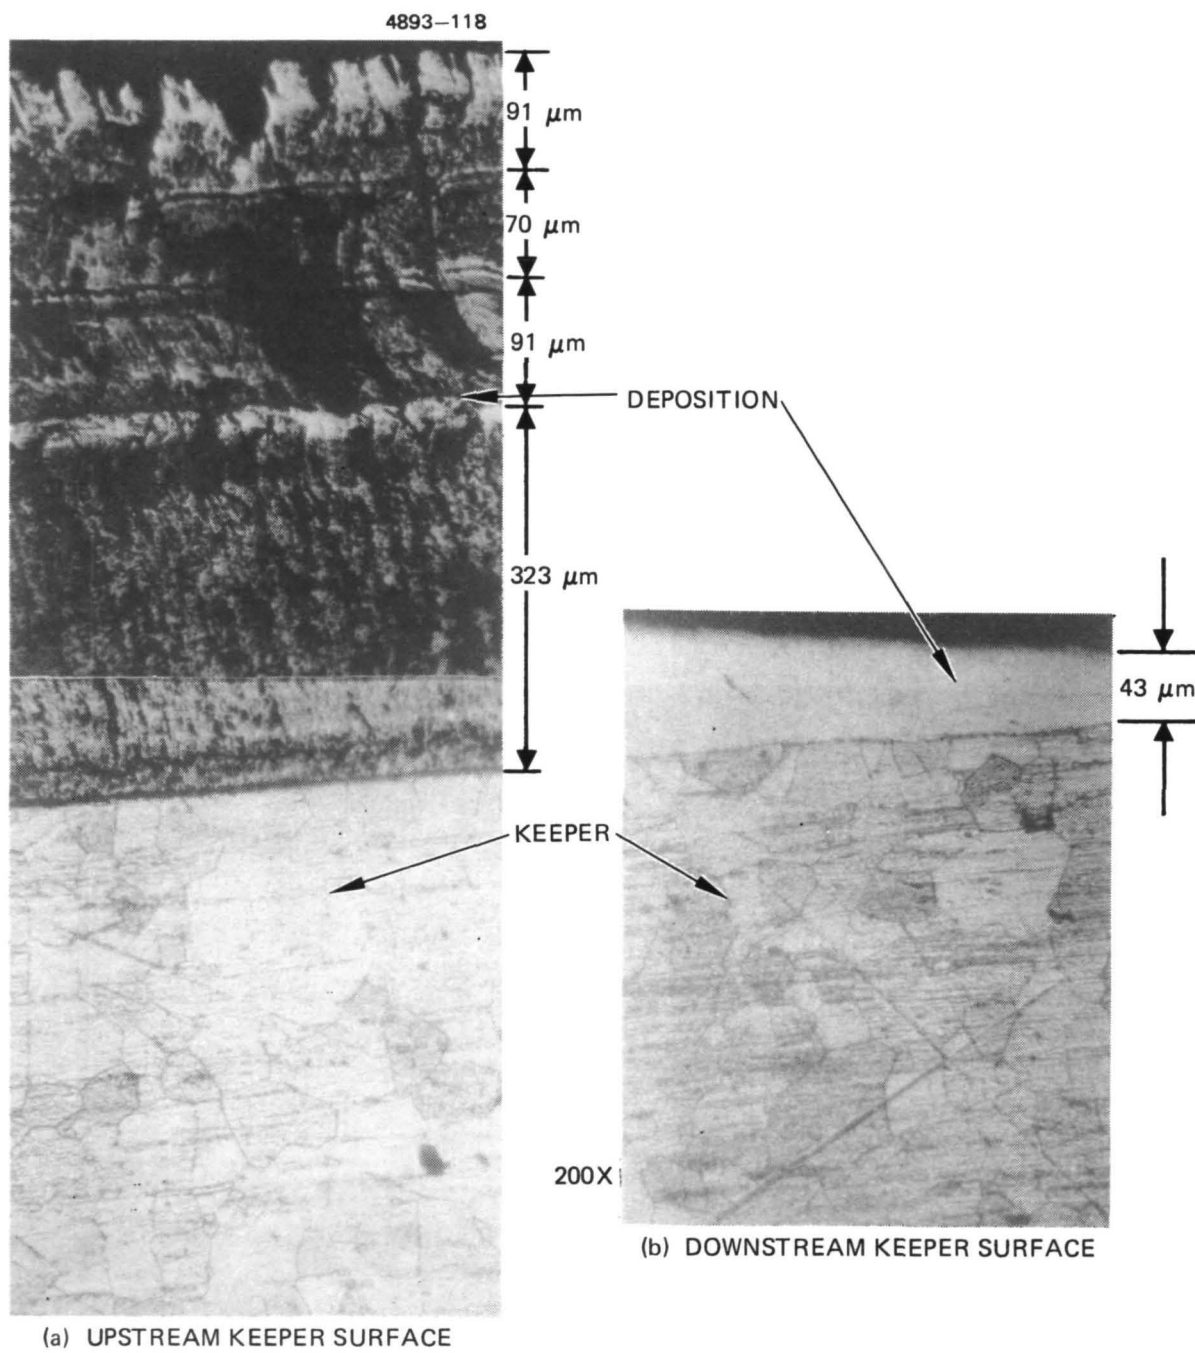
It was thought that a detailed analysis of the keeper deposits might offer some explanation of the erosion process or history and the sectioned keeper was analyzed using the E-beam microprobe. The "layered" appearance of the upstream coating seen in Fig. A-48(a) can also be seen in the SEM photograph and to some extent in the elemental analysis scans of Fig. A-49. The elements found were Fe, Ta, Ni, Cr, and K. Since the distribution was more or less uniform throughout the coating, it was not possible to establish a time history based on an abrupt appearance of one of the elements. The Fe, Ni, and Cr are thought to originate in the stainless-steel baffle coil sheath and tie-down straps, while the Ta originates in the cathode radiator. Next, an attempt was made to relate the layer thickness to test events as indicated in Table A-5, starting the layer formation at either the start of the test or at the appearance of the hole in the baffle. Changes in thruster beam current were selected as the test events for correlation. As shown in Table A-5, there is no significant relationship between the selected test events and the layer structure (thickness).

Figure A-48. Magnified views of cathode keeper.

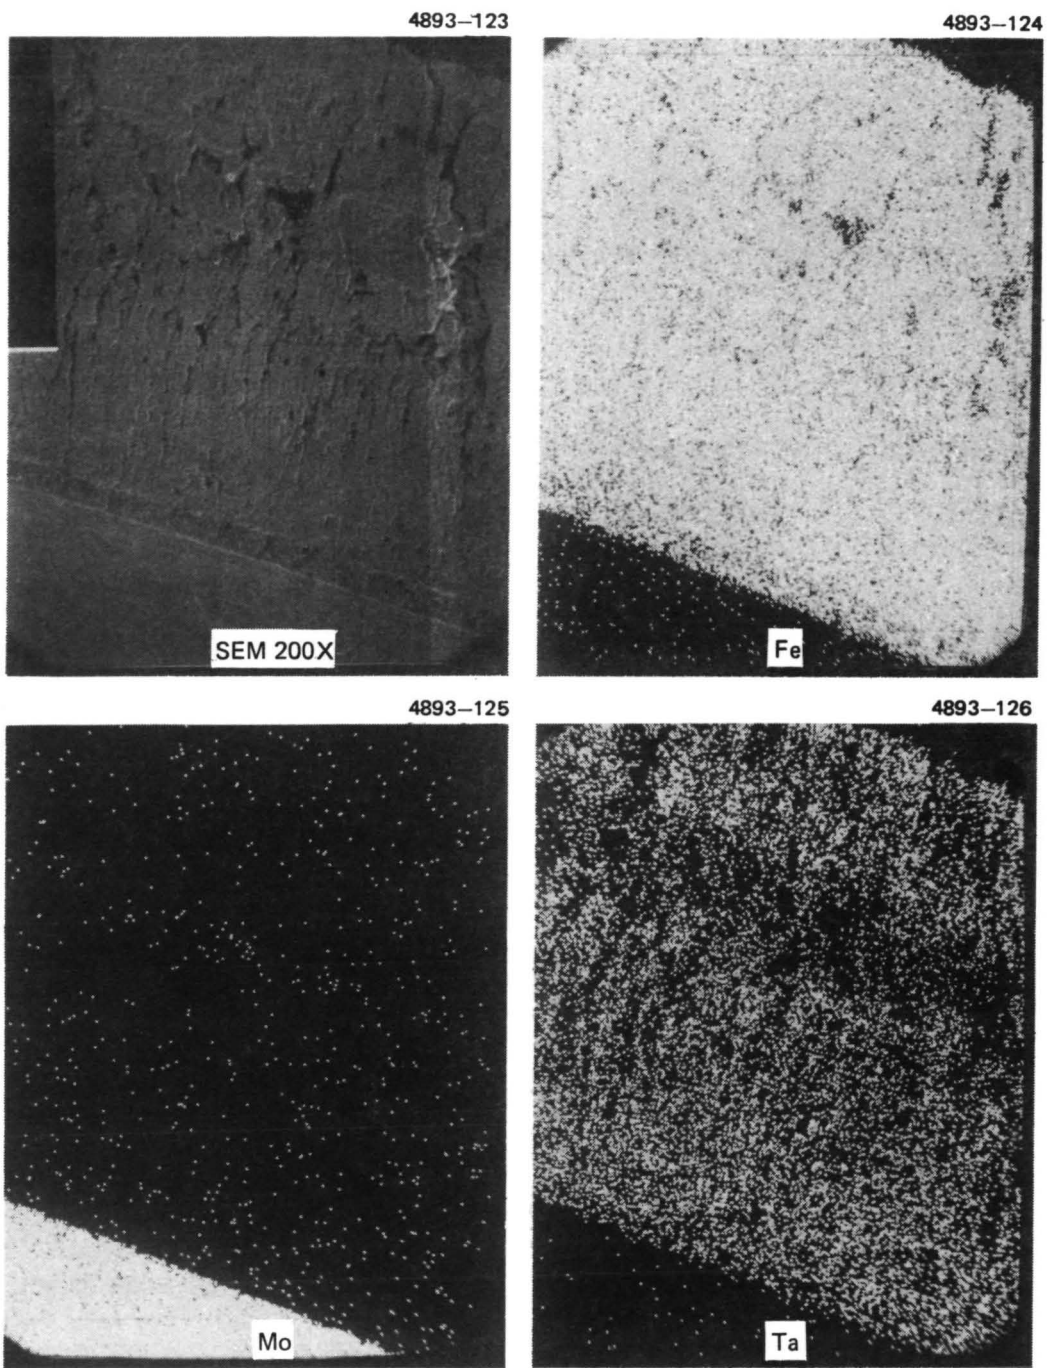
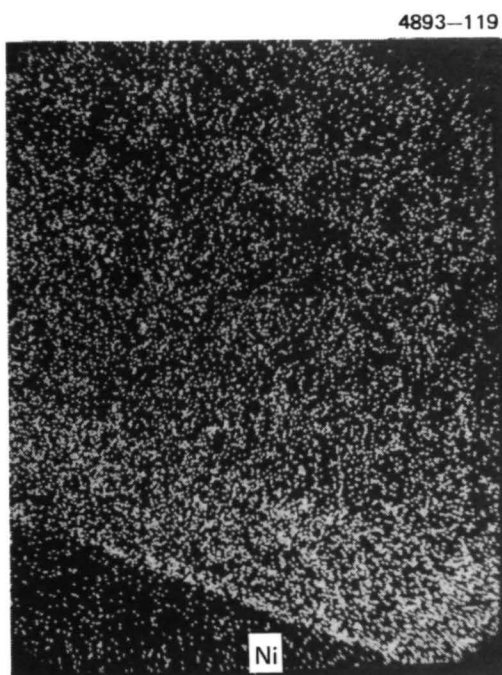
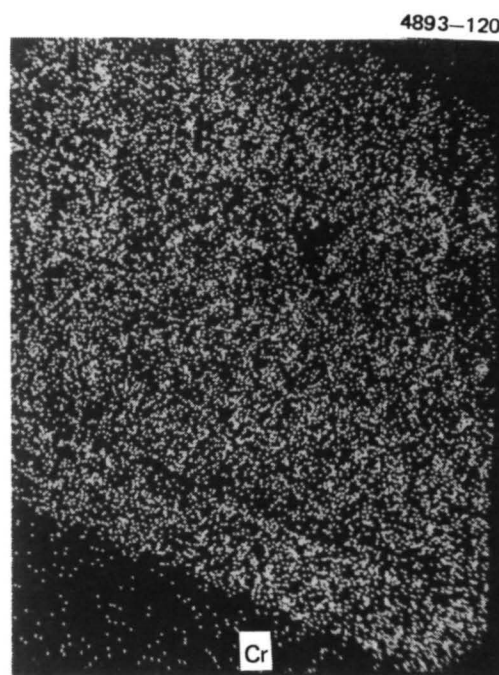
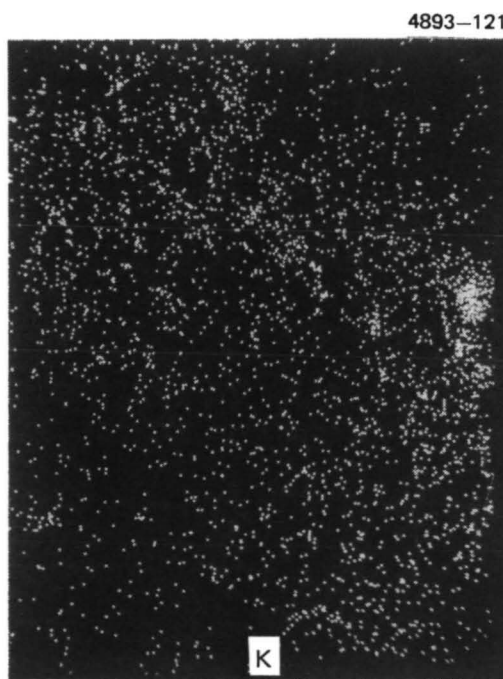
Figure A-49. SEM photo and K $\alpha$  X-ray analysis of upstream keeper coating.
